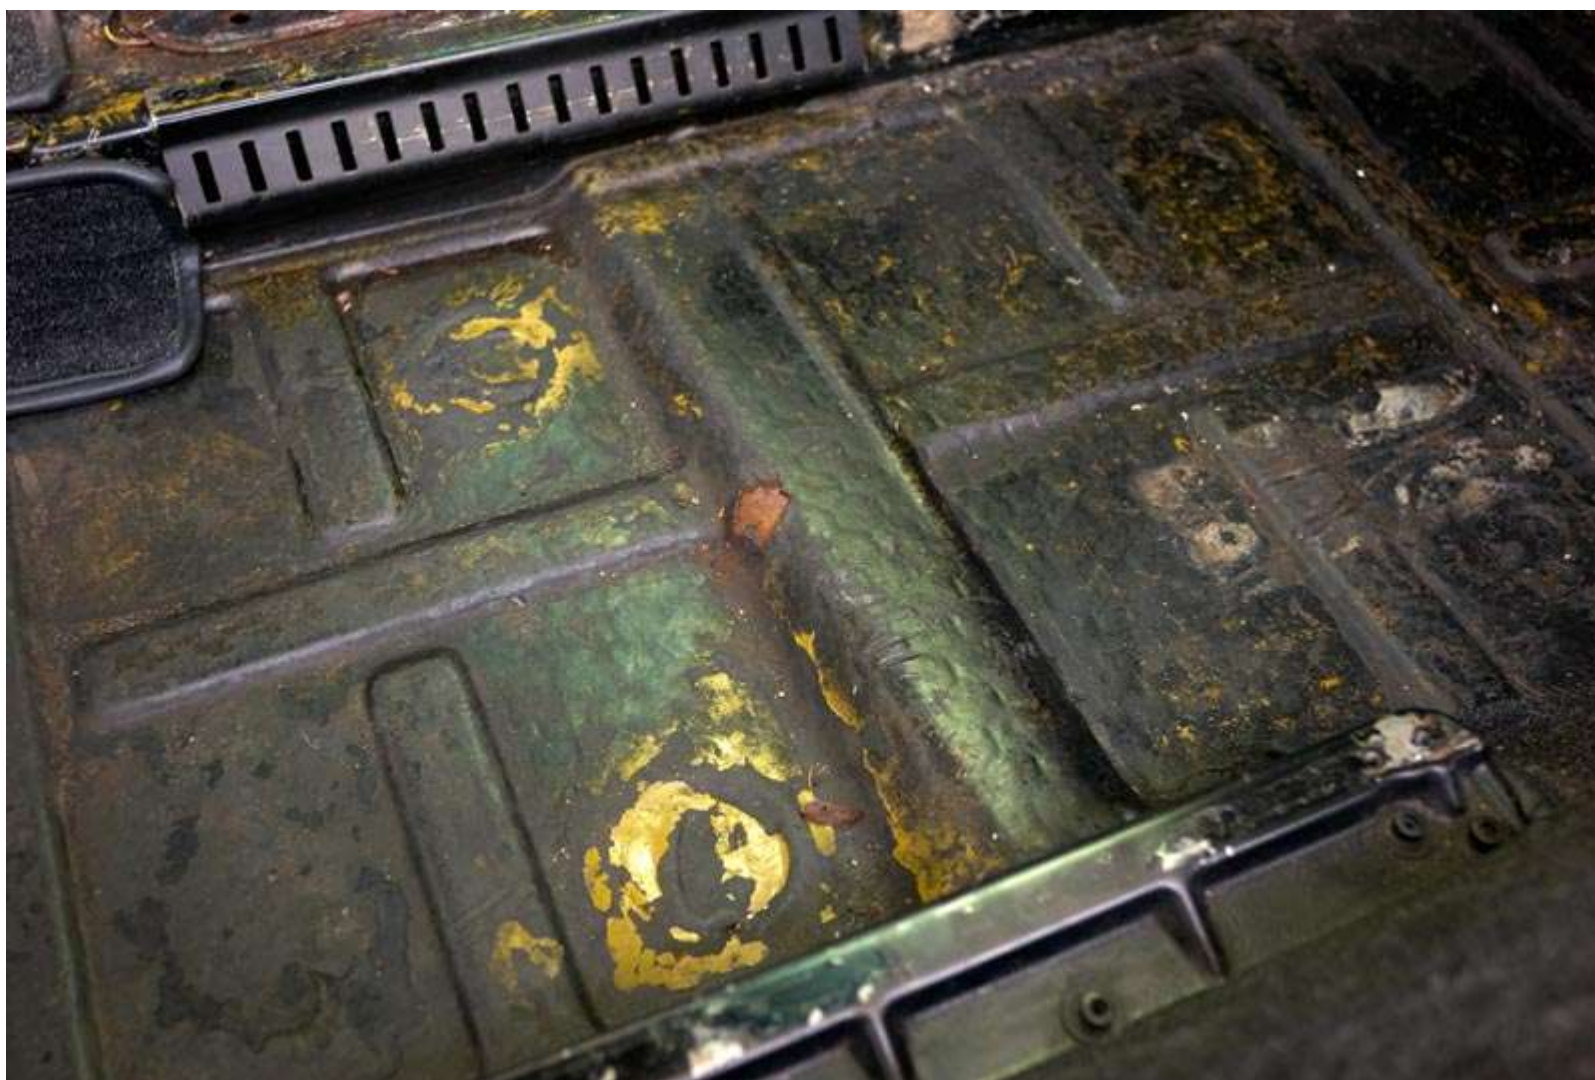
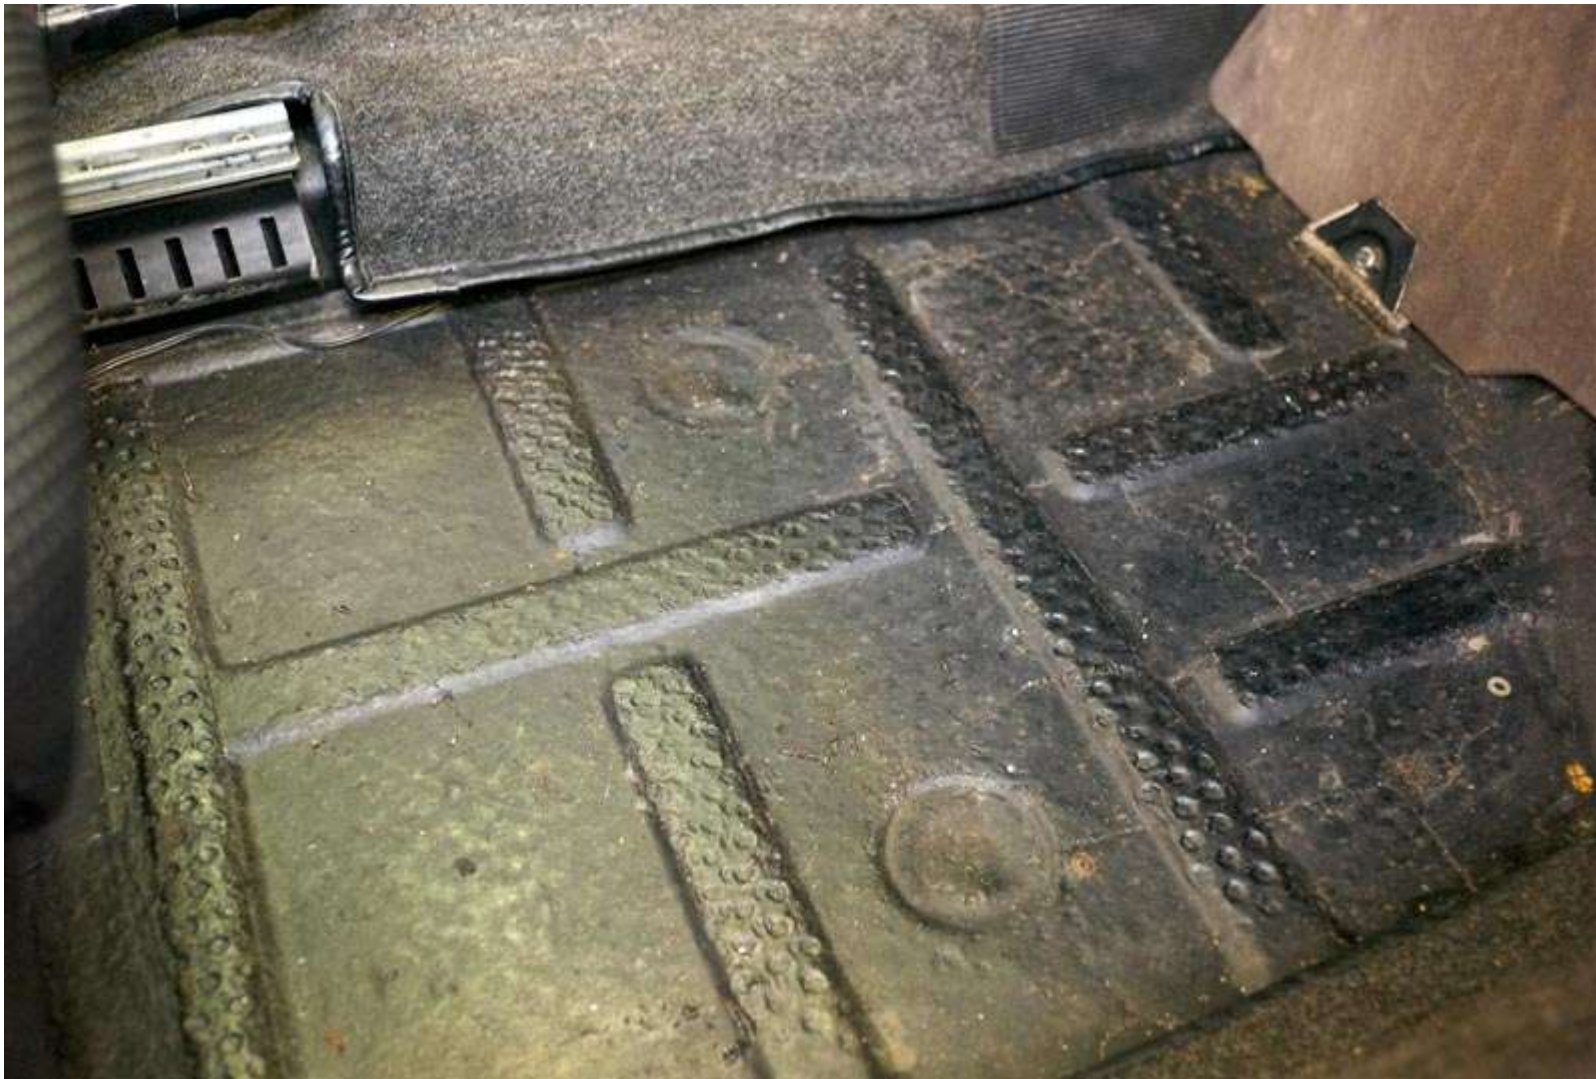
=> My mechanic and I took a detailed look at two original cars belonging to his clients, a gold 70E (early) and a silver 71E (mid). Both look exactly like Karim's car:

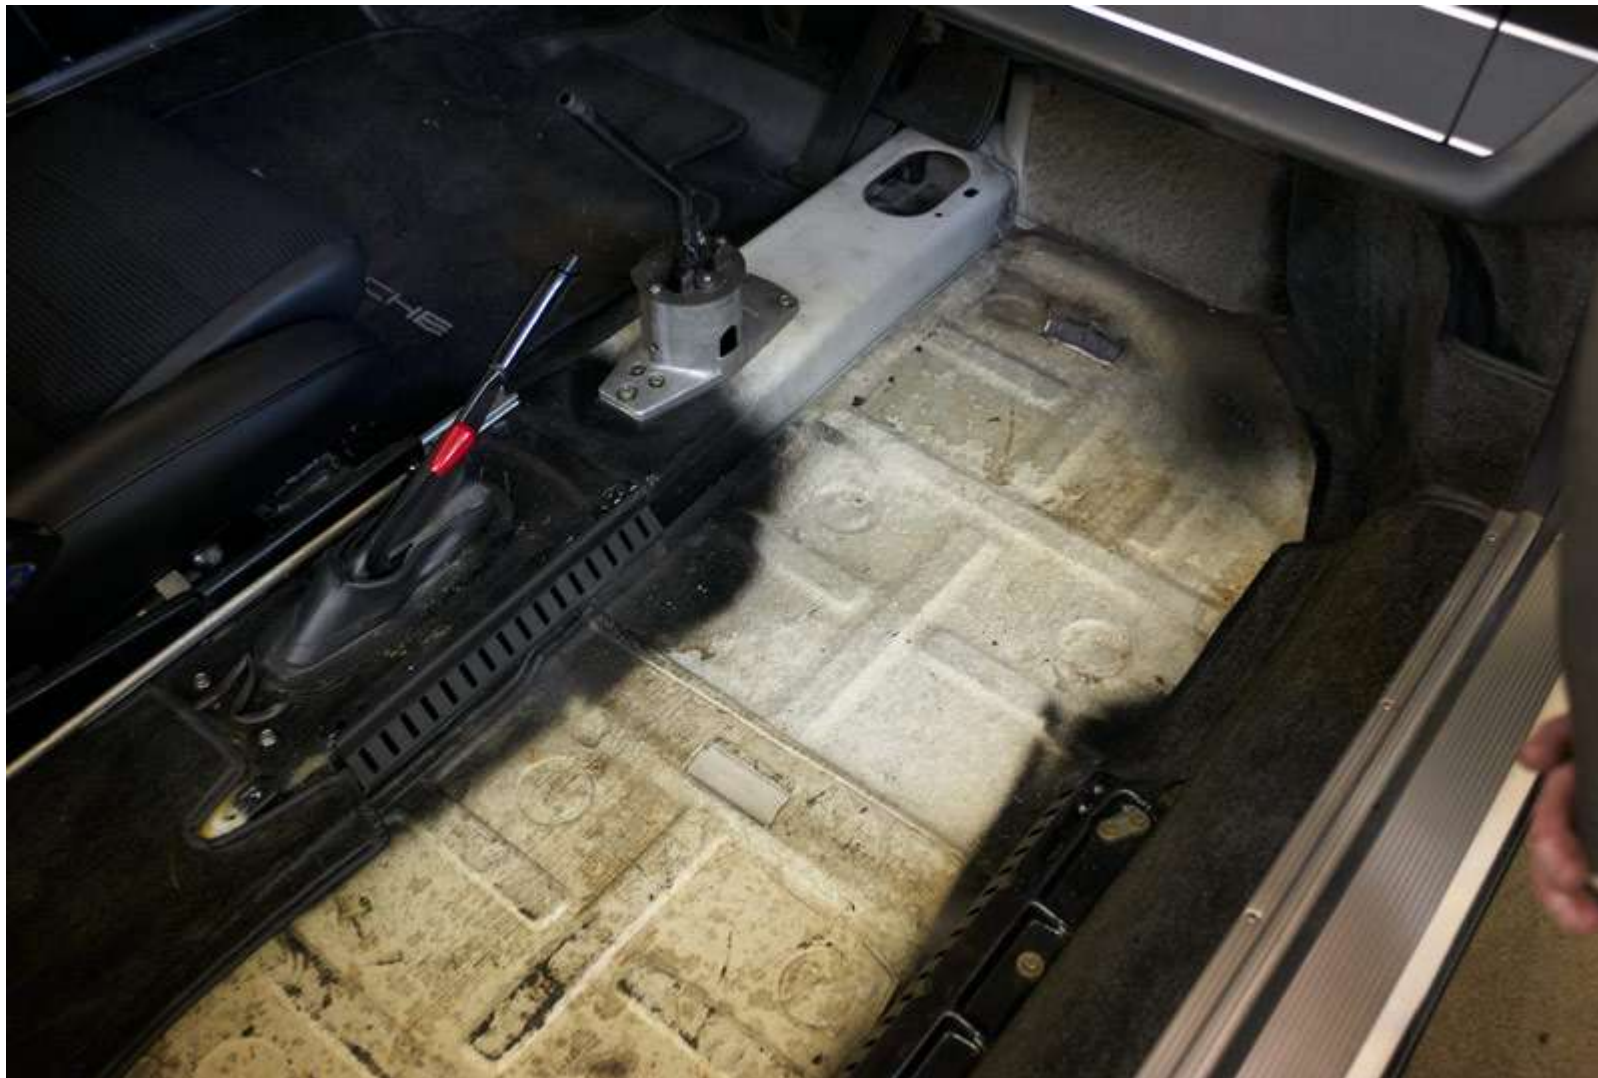
=> Finally, we also looked at a completely original RS (late third series, 1400's), which has mats first, then body color and no black overspray over the mats:

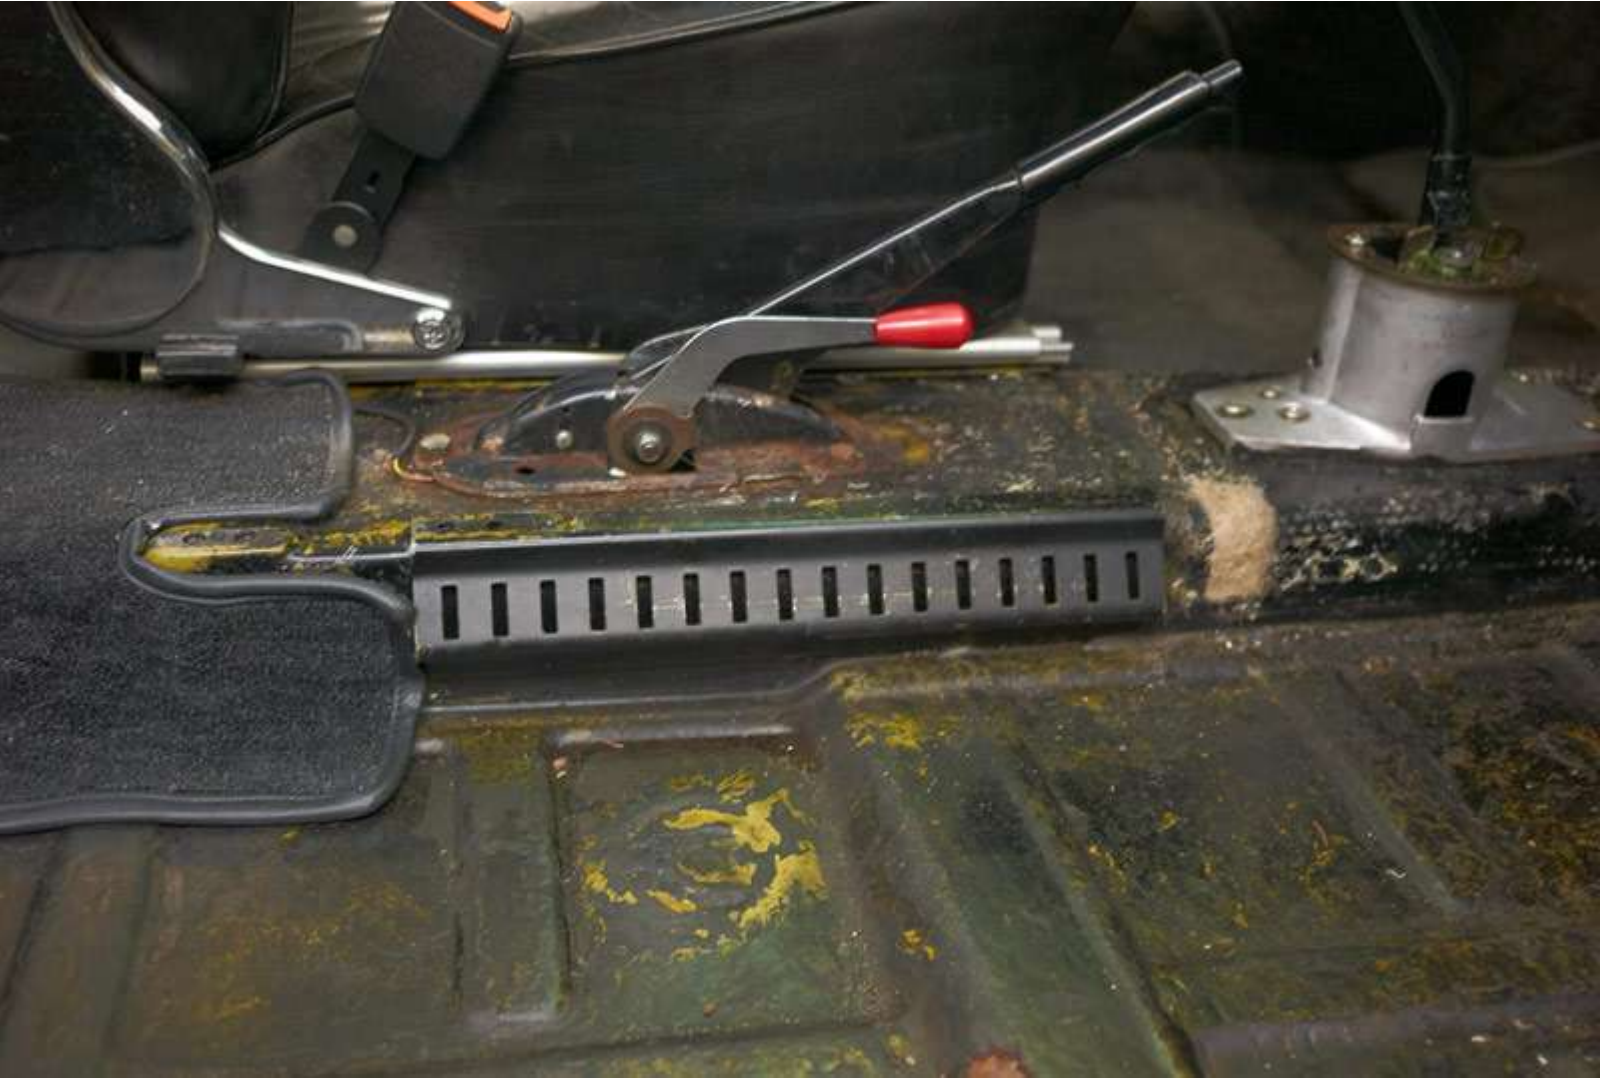
Then, with regards to the center tunnel, the 70 and 71 cars have black overspray all the way to the pedal area:

1. Generally, between 71 and 73, the overspray was done less and less (cost reasons?) and this would explain the center tunnel overspray being less on the RS than on the 70 and 71 cars. Should 72 should look closer to 70/71, just as the other areas (underbody, wheel wells, engine bay) did, or to 73??

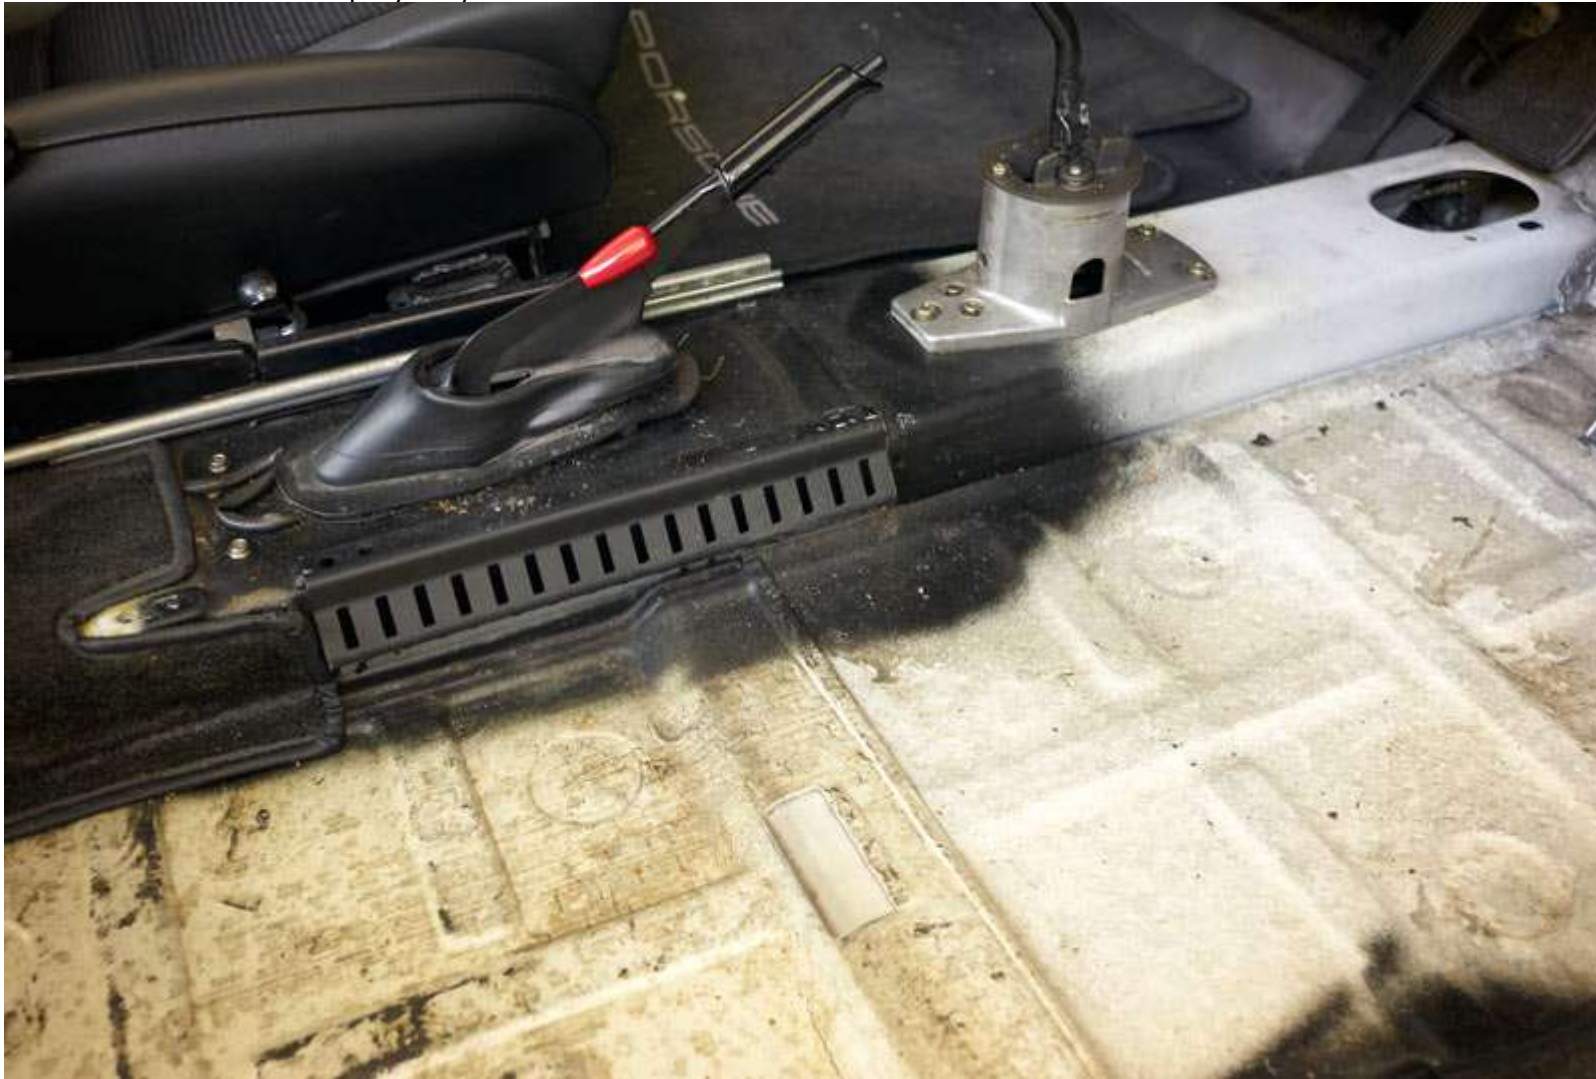
whereas the RS has overspray only around the handbrake area:
